Case Report

Implant Failure and Acetabular Protrusion Post Austin Moore Prosthesis: A Case Report

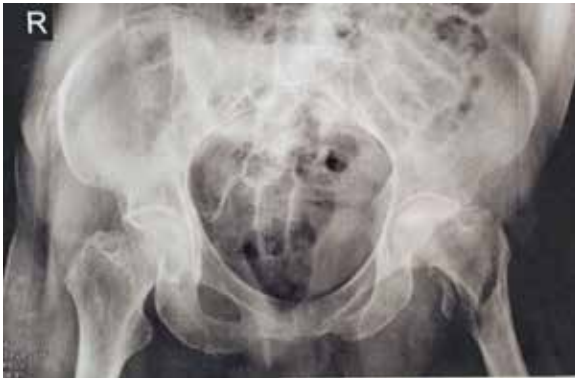
Figure 1. Pre-Hemiarthroplasty

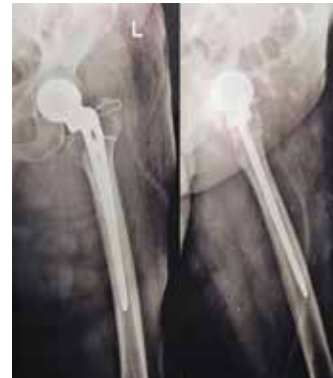
Figure 2. Post-hemiarthroplasty

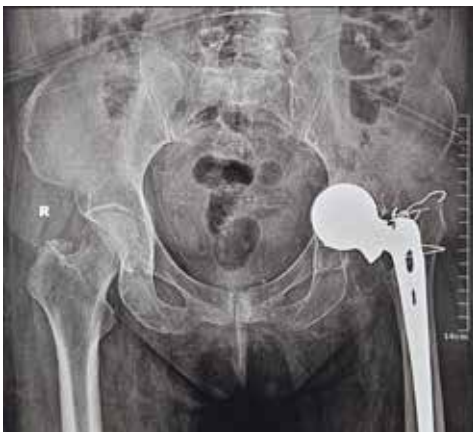
Figure 3. AMP neck fracture and acetabular protrusion before THA procedure.

Risk factors for implant failure include mechanical stress and wear, biological response to the prosthesis, and surgical technique. Mechanical stress and wear are linked to the design of the AMP, which subjects the prosthesis to significant mechanical stress, particularly in active or overweight patients (Chen et al., 2019). Over time, this can lead to material fatigue and eventual failure of the prosthesis. The biological response, such as osteolysis and aseptic loosening, also contributes to implant failure. The body's immune response to wear particles from the prosthesis can cause bone resorption around the implant, leading to loosening and failure (Smith et al., 2020). Surgical technique and initial placement of the prosthesis play critical roles, as improper alignment or positioning during surgery can increase the risk of stress concentrations and implant loosening (Jones & Wang, 2021). Surgeons' experience and precision are crucial to minimizing these risks. This case illustrates implant failure linked to the AMP design, which lacks an acetabular component, which generates significant mechanical stress and wear on the acetabulum, accelerating its erosion. The continuous stress and friction also cause material fatigue, making the implant prone to breakage. The situation is exacerbated by additional trauma from the fall. Thus, the combination of mechanical stress, accelerated wear, and material fatigue from the outdated AMP design directly contributes to the

implant's failure and the resultant acetabular protrusion.

Acetabular protrusion involves the migration of the prosthetic component into the acetabulum, often leading to severe pain and functional impairment. This condition typically arises from chronic mechanical stress and bone resorption around the implant site (Lee et al., 2021). Risk Factors for Acetabular Protrusion are 1) Bone Quality, Osteoporosis, and poor bone quality are significant risk factors for acetabular protrusion. Elderly patients, particularly postmenopausal women, are at higher risk due to decreased bone density, making the acetabulum more susceptible to erosion and protrusion (Liu et al., 2019). 2) Prosthesis Design, which does not include an acetabular component, can lead to increased wear on the acetabulum. Over time, this can cause the prosthetic head to migrate into the pelvic cavity, resulting in acetabular protrusion (Kim et al., 2020). 3) Inadequate Prosthetic Fit between the prosthesis and the patient's bone can lead to micro-movements and increased pressure on the acetabulum. This can accelerate the erosion process and lead to protrusion (Garcia-Rey et al., 2018). The plain radiograph in this case confirmed the diagnosis, necessitating a THA to replace the AMP and address the acetabular defect.

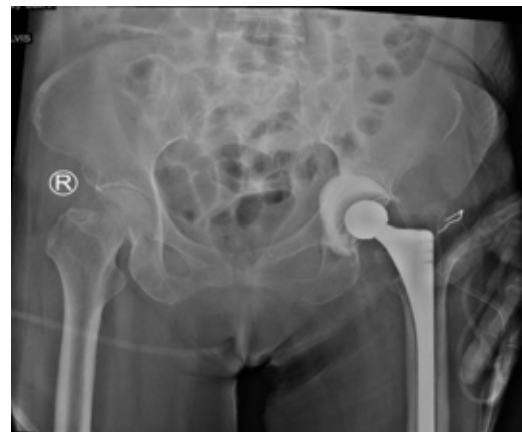
Figure 4. Post THA procedure.

The use of a hybrid THA system, combining a cemented cup and an uncemented long stem, was chosen to provide a stable and durable solution for this patient. This approach helps ensure better fixation and load distribution, which is crucial for patients with compromised bone quality (Siddiqi et al., 2022). In this case, the decision to utilize a hybrid THA system (cemented cup and uncemented long stem) was driven by the need to address both the acetabular protrusion and the AMP neck fracture. Literature indicates no significant difference in revision risks between cemented and hybrid systems, suggesting that the choice of system should be tailored to individual patient needs and anatomical considerations (Konan et al., 2020). The cemented cup was particularly chosen due to its immediate fixation capability, which is vital for early postoperative mobilization, and its reliability in patients with poor bone quality. Furthermore, the surgeon's experience and preference for cemented techniques played a role in this decision, as these techniques have demonstrated successful outcomes over the years. Post-operative care in the high-care unit was essential to monitor for potential complications, such as bone cement implantation syndrome, a risk associated with cemented components (Gomez-Hernandez et al., 2019). This is a potentially life-threatening complication, although no complications were observed in this patient (Olsen et al., 2018).

A small medial wall defect in this case suggests that the primary structure of the acetabulum remains largely intact. This allows for a prosthetic cup that closely matches the original shape of the patient's acetabulum, ensuring a more anatomical fit. In this scenario, the cement fixation is enough to provide stability. It offers immediate fixation and load distribution, which
